**Loss of Pitch Control on Takeoff  
Emery Worldwide Airlines, Flight 17  
McDonnell Douglas DC-8-71F, N8079U  
Rancho Cordova, California  
February 16, 2000**

**NTSB/AAR-03/02**

**NTSB/AAR-03/02  
PB2003-910402  
Notation 7299A  
Adopted August 5, 2003**

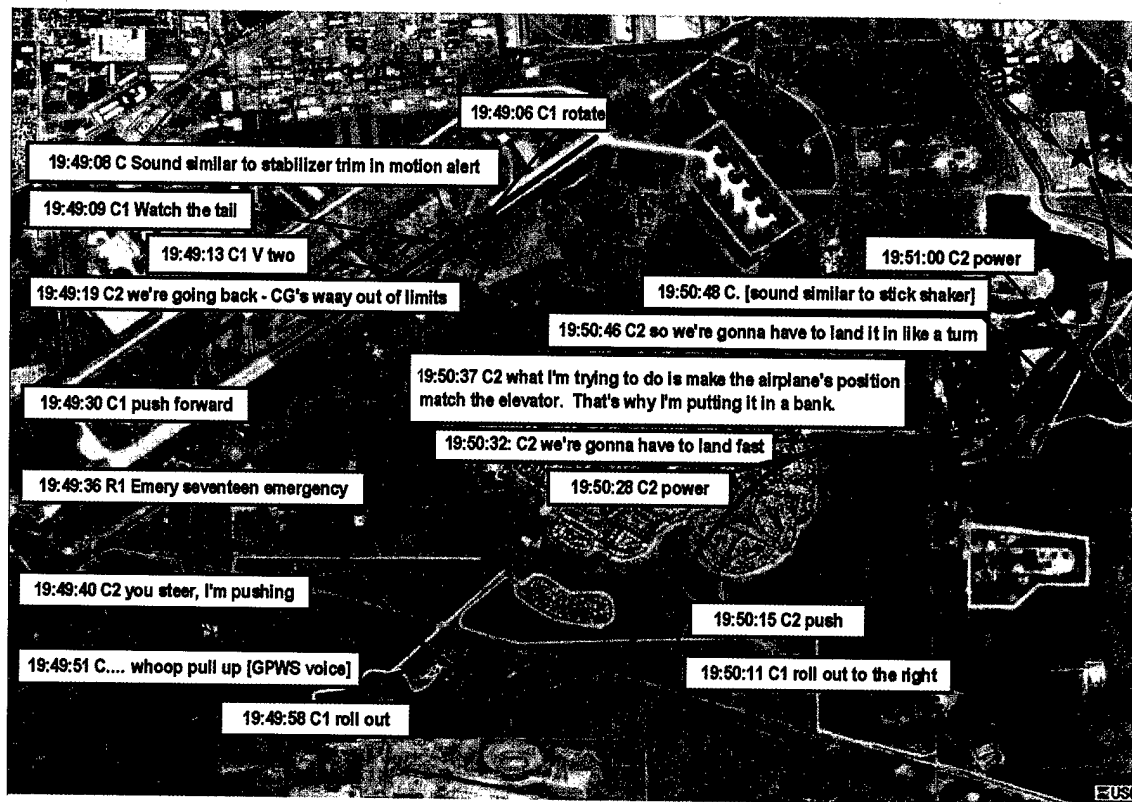
The airplane impacted the ground in a left-wing-low, slightly nose-up attitude in an automobile salvage yard, about 1 mile east of the departure runway. Figure 1 shows the airplane's ground track, with selected CVR comments, during the accident flight. (For additional information regarding CVR comments, see the CVR transcript in appendix B).

Figure 1. The airplane's ground track, with selected CVR comments, during the accident flight.

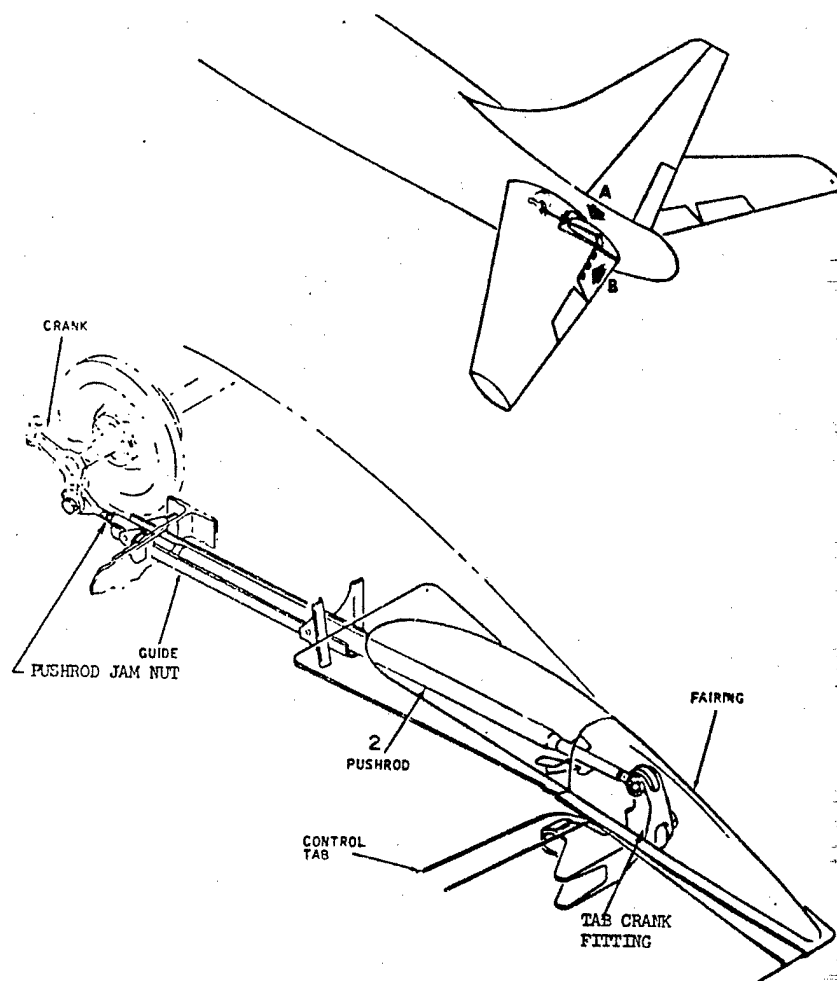
Each elevator control tab is hinged to the inboard trailing edge of the associated elevator surface, then connected by a mechanical linkage (including a crank fitting, pushrod, and bellcrank assembly) at the inboard edge of the tab to the flight control system on that side of the airplane. Figure 2 is a diagram of the elevator control tab installation. The elevator control tabs are in their neutral position when they are in line with the elevator surfaces and should have a maximum TEU deflection of  $8.5^\circ \pm 0.5^\circ$  and a maximum TED deflection of  $26.5^\circ \pm 0.5^\circ$  from that neutral position.

**Figure 2.** A diagram of the elevator control tab installation.

(See figure 2, in section 1.6.2, for a diagram of the elevator control tab installation.) The right control tab pushrod was recovered separately, with its aft rod end (which would normally have been bolted to the tab crank fitting) intact. Examination of the forward edges of the elevator control tab crank fitting lugs revealed evidence of repeated contact damage (including gouge marks and indentations). (Figure 9 is a photograph of damage to this area.) The internal surfaces of the pushrod aft rod end bearing and the bushings in the crank fitting lugs showed no visible signs of damage or deformation. The bolt and associated hardware that normally secures the right elevator control tab pushrod to the tab crank fitting<sup>61</sup> was missing and not recovered.

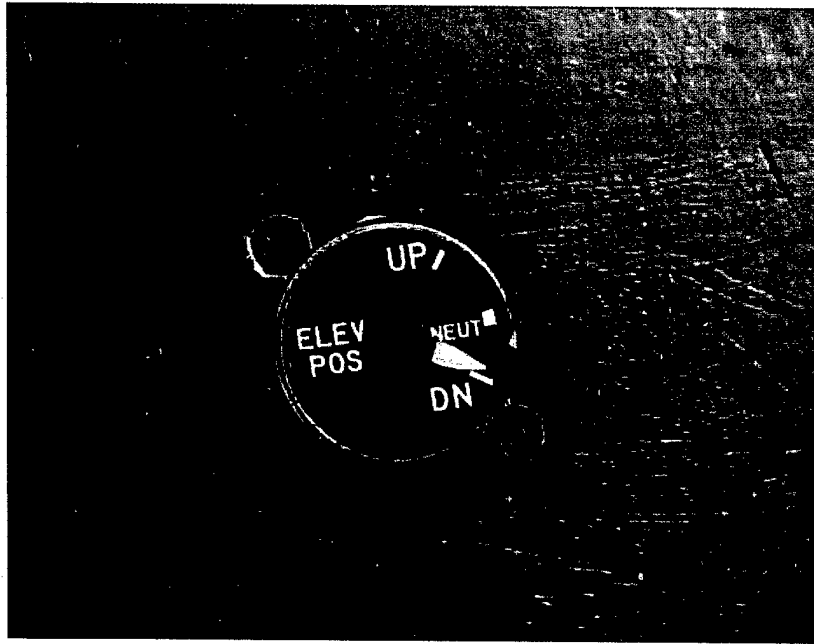
The DC-8 EPI is a 1-inch diameter circular cockpit gauge with a pointer needle and index markings for UP, DN (down), and NEUT (neutral) positions to indicate the position of the elevators. When the EPI is properly calibrated, the up index mark should correspond to the maximum TEU elevator surface position of 27° and the down index mark should correspond to the maximum TED elevator surface position of 16.5° TED. A narrow white band adjacent to the NEUT index mark indicates an elevator surface position between 0° and 5° TEU. Figure 3 is a photograph of an EPI gauge similar to that on the accident airplane.

**Figure 3.** A photograph of an EPI gauge similar to the gauge installed on the accident airplane.

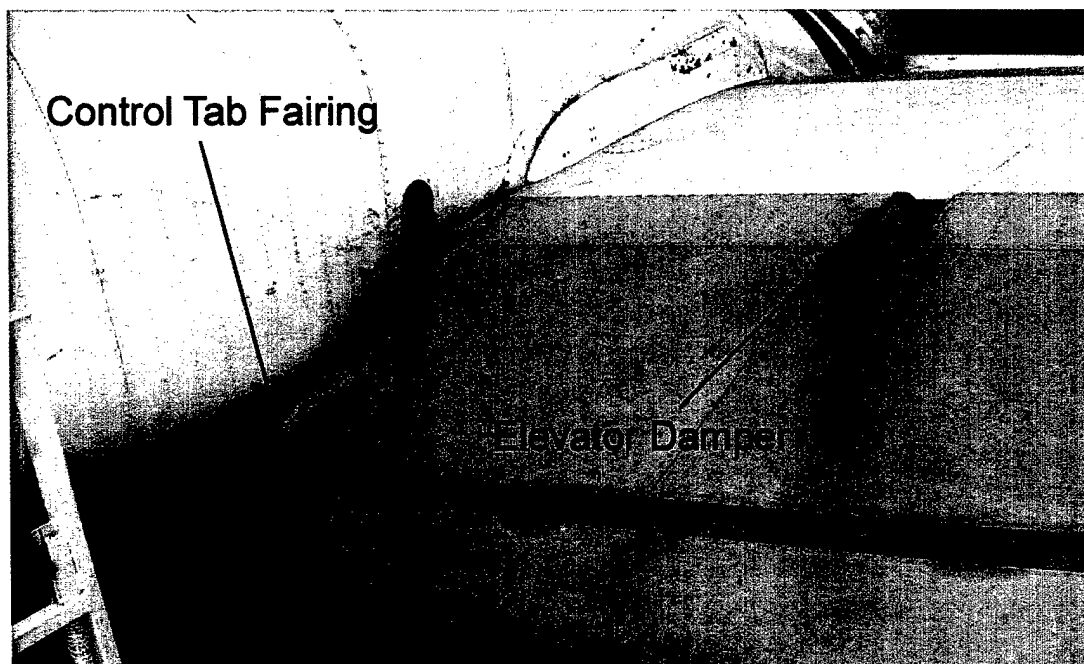
The accident airplane's maintenance records revealed that on November 25, 1999, eight days after the D inspection was completed (which included the installation of the elevator assemblies), a pilot reported that he had to apply "more back pressure than normal" on the control column to flare during the preceding landing and during the elevator check before the previous takeoff. The corrective action for this pilot report (performed by Emery maintenance personnel) was described in the accident airplane's maintenance logbook as follows: "Found [left/right] elevator dampers reversed, moved [left to right] side, [right to left] side, ops ck'd good, no defects noted." Figure 5 shows the elevator damper's location on the right elevator of a DC-8.

**Figure 5.** Photograph showing the elevator damper's location on the right elevator of a DC-8.

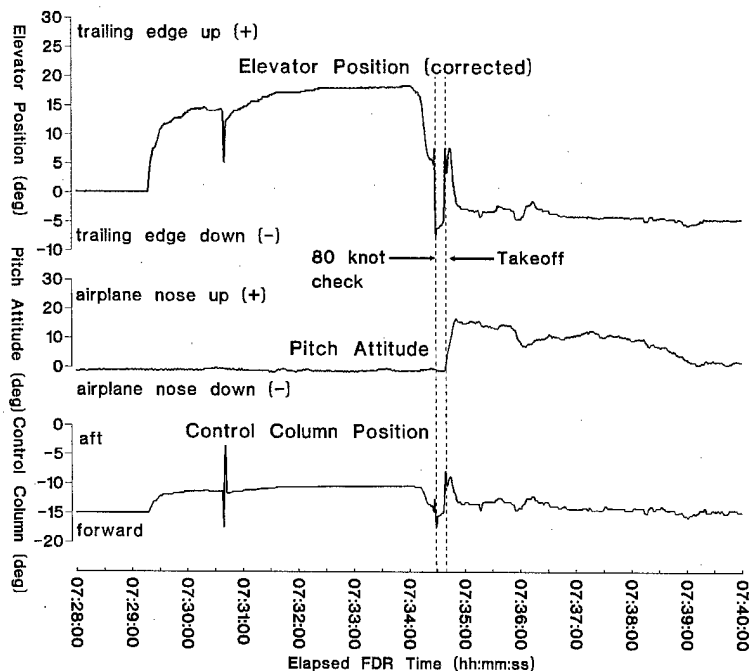
The Safety Board's examination of the corrected elevator position data revealed that the airplane's elevator never traveled below its neutral position to a TED deflection during the accident flight, although recorded forward control column inputs should have resulted in a TED elevator deflection. For example, although the FDR data indicated that, during the 80-knot elevator check at MHR, the control columns were moved to about 6° forward of their rigged neutral position, the elevators did not deflect below 2.2° TEU. In contrast, during the 80-knot elevator check on the previous takeoff (at RNO) the FDR recorded elevator movement to 8° TED, with less forward control column movement. Figure 7 shows plots of the pitch attitude, control column position, and elevator position FDR data for the accident flight. Elevator position is shown using the conversion that corrected for the 11° offset. Figure 7 also shows when the 80-knot elevator check and takeoff occurred. Figure 8 shows the same information for the takeoff from RNO.

**Figure 8.** Pitch attitude, control column position, and (corrected) elevator position FDR data for the previous takeoff from RNO. About the first 1 minute 20 seconds of data were recorded while the gust lock was engaged.
